PROJECT HIGHLIGHT

Miami Beach Police Department • Miami Beach, FL

Garland's Plaza Deck System Seals, Waterproofs Police Station

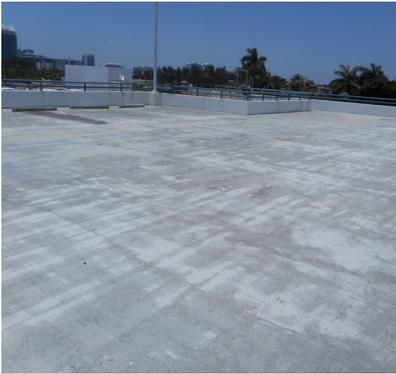
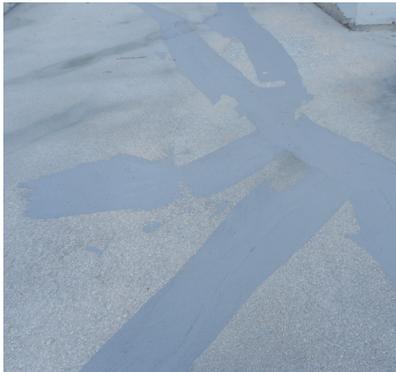
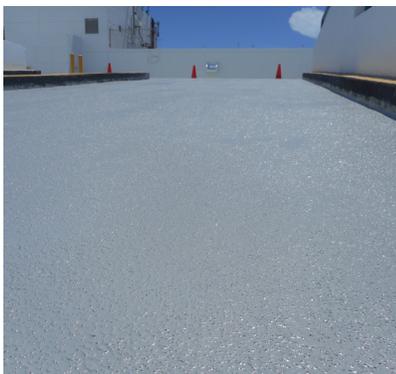
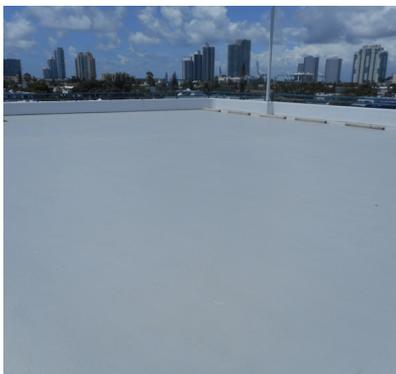
The city has a diligent preventive maintenance program that requires buildings to be inspected yearly with work prioritized based on urgency. As a part of that maintenance program, Duarte worked with local Garland representative, Matt McDermott, to perform a building envelope and structural analysis on the parking garage. It was determined that the parking garage's horizontal and perimeter joints were failing, allowing water to enter the building. Additionally, the waterproofing for the vehicle impound area had completely worn away or failed in many areas.

The top deck of the parking garage and ramp was stripped, primed and then coated with Garland's Dura-Walk® plaza deck elastomeric waterproofing system, including a base coat, wear coat and top coat. The wear coat included sand aggregate to provide traction and additional wear protection. Additionally, old joints were removed and new, oversized backer rod was installed and then resealed with Garland's high-performance Green-Lock® Sealant XL adhesive sealant designed to accommodate the most severe building movements. The walls, columns and parapets were coated with Garland's Tuff-Coat™ acrylic architectural wall coating to provide dampproofing protection. McDermott coordinated the project with Hartzell Construction, Inc. of Pompano Beach, Florida.
